**Flood Control Project Maintenance
Levee Inspections**

Fall 2011 Levee Maintenance Deficiency Summary Report

Sacramento River Basin

Reclamation District No. 1660 Tisdale

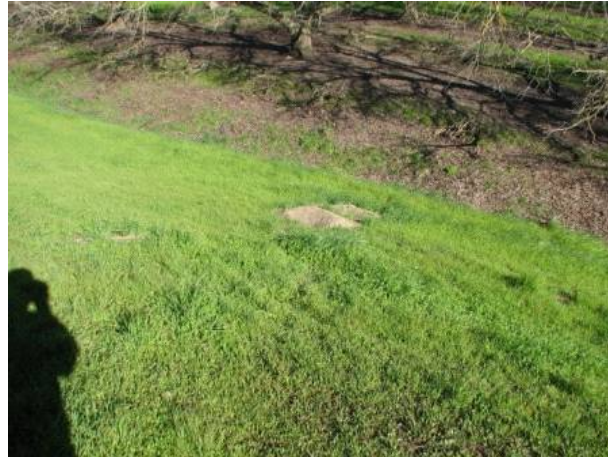
Levee Mile Report Line	1
Start Levee Mile	0.08
End Levee Mile	0.10
Location	Land Side
Category	Earthen Levee
Item	Animal Control

View of squirrel holes along the slope.

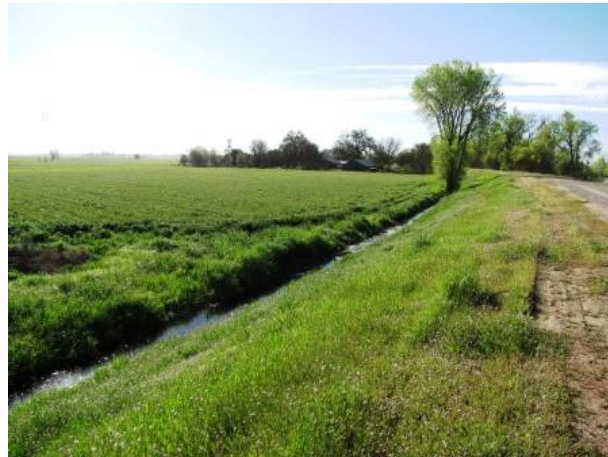
Levee Mile Report Line	4
Start Levee Mile	1.12
End Levee Mile	1.43
Location	Land Side
Category	Earthen Levee
Item	Encroachments

View of the AG ditch along the L/S toe.

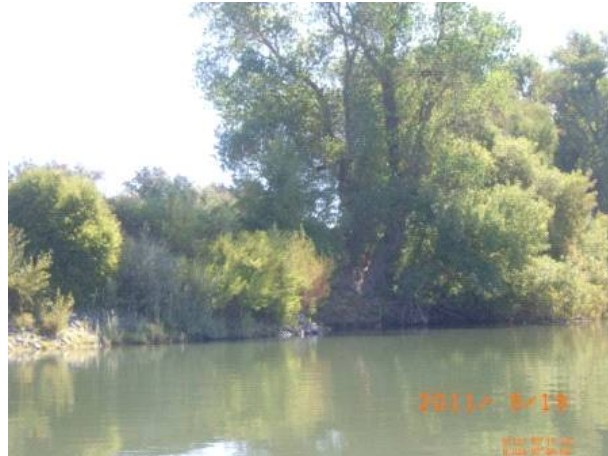
Levee Mile Report Line	5
Start Levee Mile	1.26
End Levee Mile	1.26
Location	Water Side
Category	Supplemental
Item	USACE Erosion Survey

USACE 2011 Photo #1

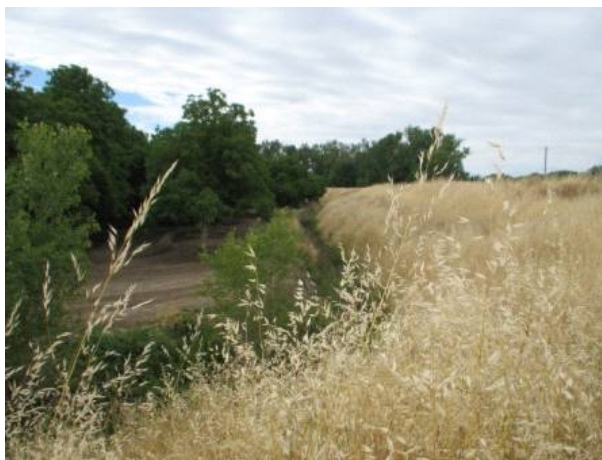
Levee Mile Report Line	6
Start Levee Mile	2.04
End Levee Mile	2.38
Location	Land Side
Category	Earthen Levee
Item	Encroachments

View of the large ditch along the landside toe.

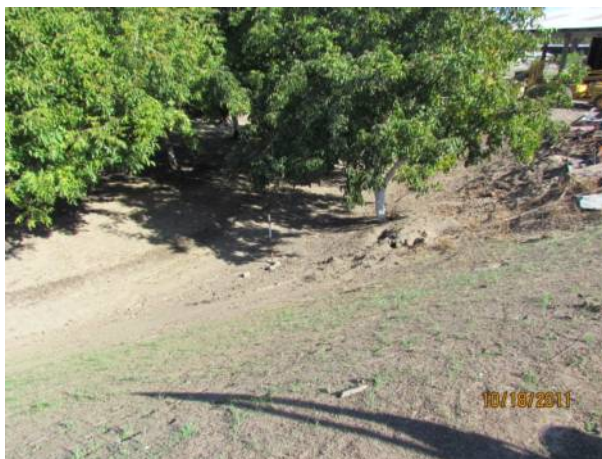
Levee Mile Report Line	9
Start Levee Mile	2.62
End Levee Mile	2.62
Location	Land Side
Category	Earthen Levee
Item	Animal Control

View of rodent holes along the L/S slope.

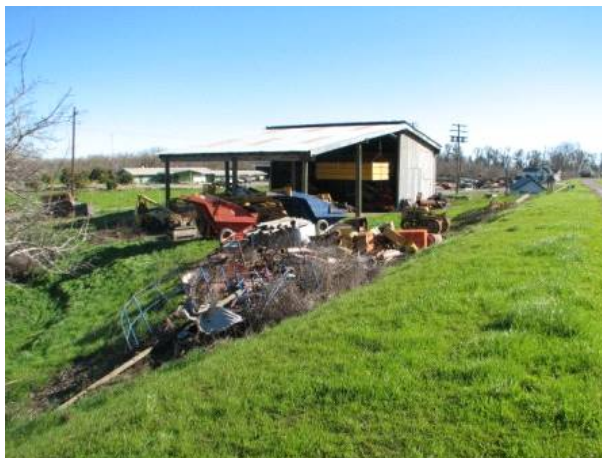
Levee Mile Report Line	10
Start Levee Mile	2.63
End Levee Mile	2.63
Location	Land Side
Category	Earthen Levee
Item	Encroachments

View of equipment along the slope.

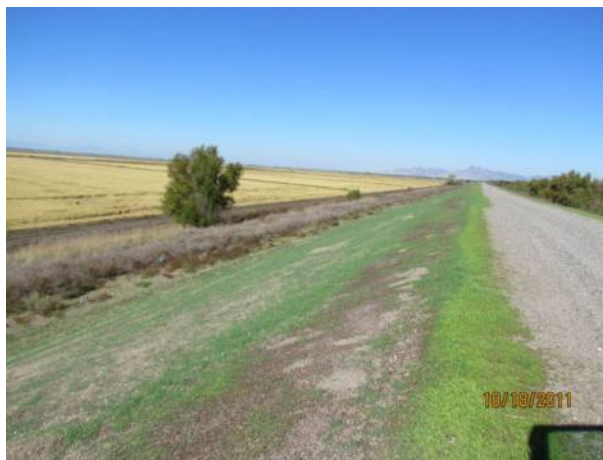
Levee Mile Report Line	2
Start Levee Mile	0.93
End Levee Mile	0.97
Location	Land Side
Category	Earthen Levee
Item	Animal Control

View of rodent holes along the L/S slope.

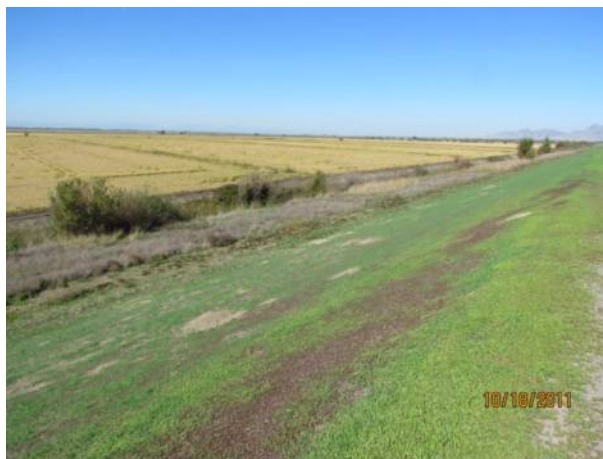
Levee Mile Report Line	3
Start Levee Mile	1.57
End Levee Mile	1.61
Location	Land Side
Category	Earthen Levee
Item	Animal Control

View of rodent holes along the L/S slope.

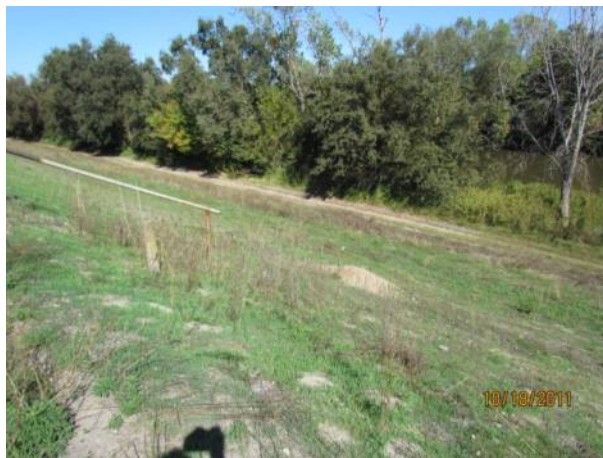
Levee Mile Report Line	5
Start Levee Mile	5.07
End Levee Mile	5.07
Location	Water Side
Category	Earthen Levee
Item	Animal Control

View of the rodent holes along the W/S slope.
